RCRA SITE SAMPLING REPORT

FORMER CW PROCESS COMPANY;
AKA WAYNE MANUFACTURING
(EPA ID No. IAD005277256)
Cedar Rapids, Iowa

IN SUPPORT OF
THE U.S. ENVIRONMENTAL PROTECTION AGENCY REGION 7

May 20, 2011

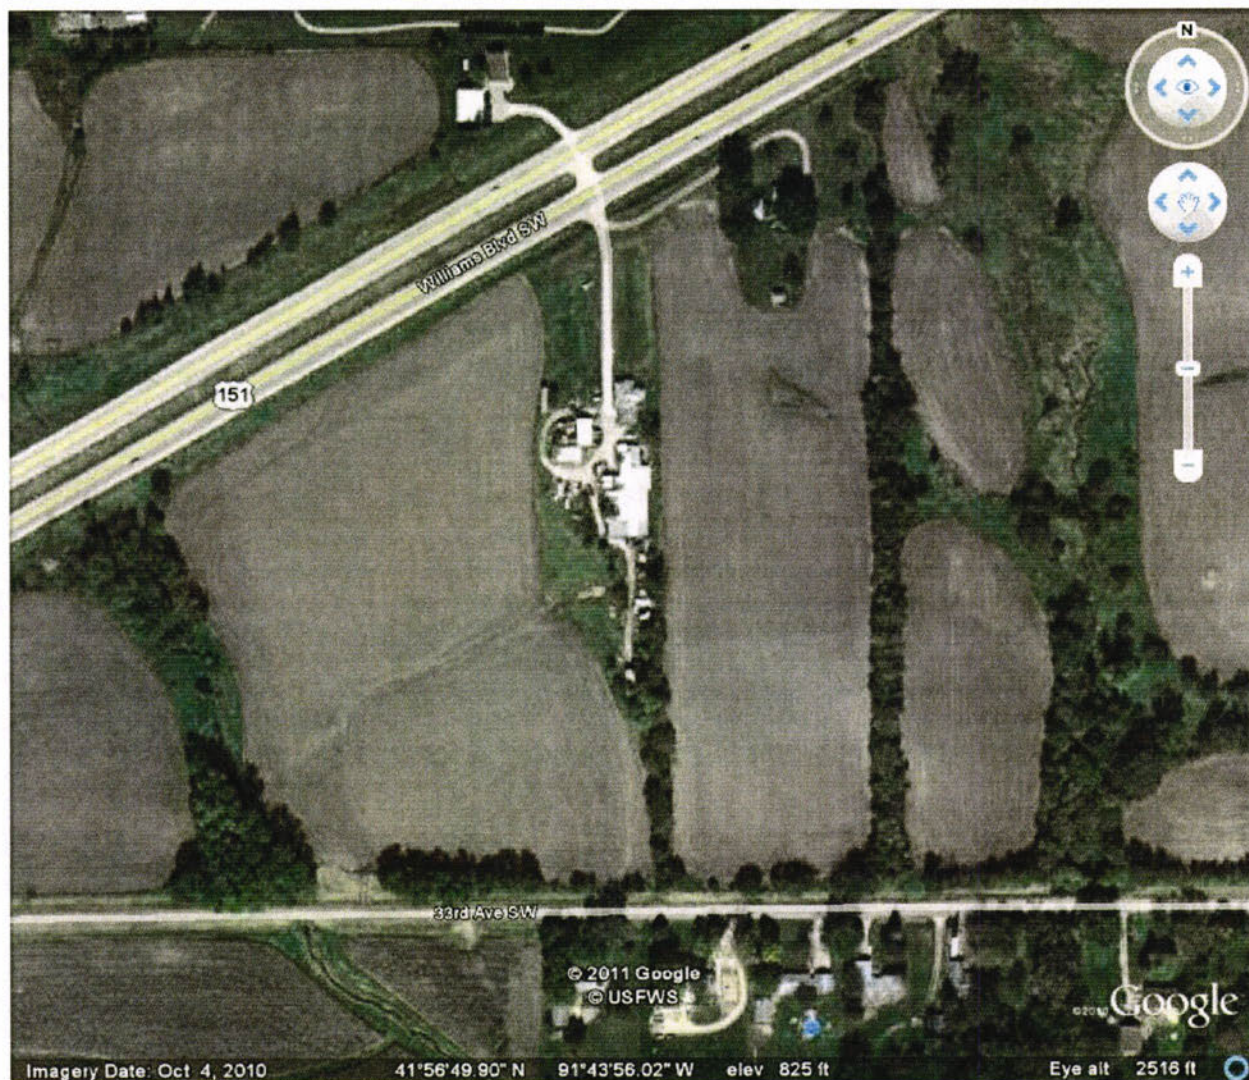
Map A. Google Earth Aerial. Scale: 1 inch = approximately 305 feet.

The manufacturing and storage buildings associated with the former CW Process site are located on a north-south strip of land. The property surrounding the site is in agricultural and residential use. An aerial map from Google Earth, showing the neighboring property, is included as Map A below.

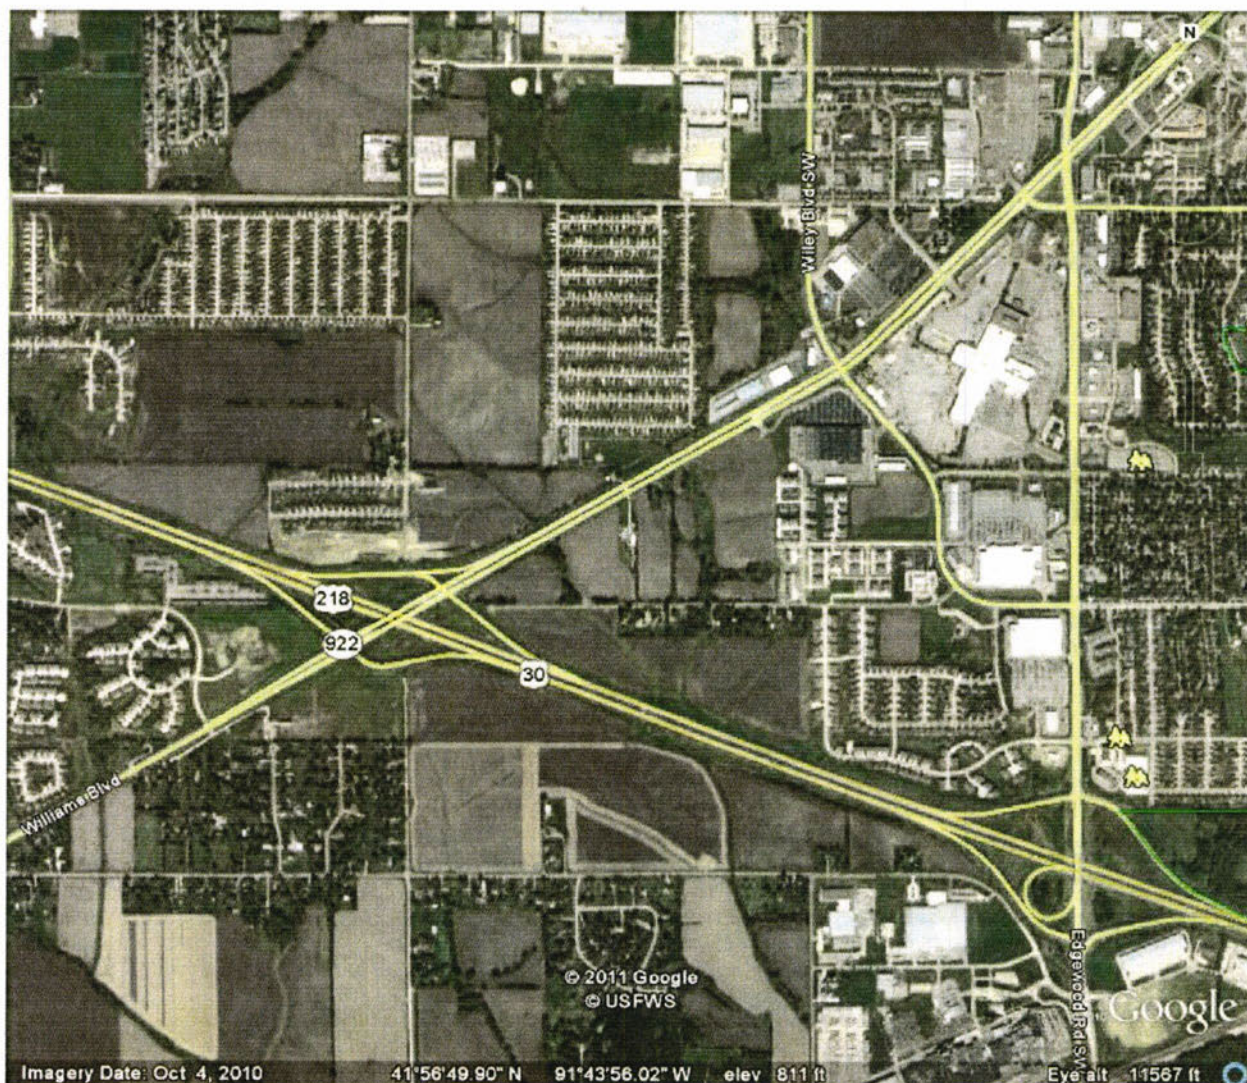
Map B. Google Earth Aerial. Scale: 1 inch = approximately 1,900 feet.

Booz Allen also used Google Earth Public to identify public use areas within approximately one mile of the site. A second Google Earth map with a larger scale (i.e., zoomed out from the Map A view) is included as Map B. Public use areas, such as schools, parks/recreation areas, and hospitals were selected to be shown as icons on the Google Earth map.

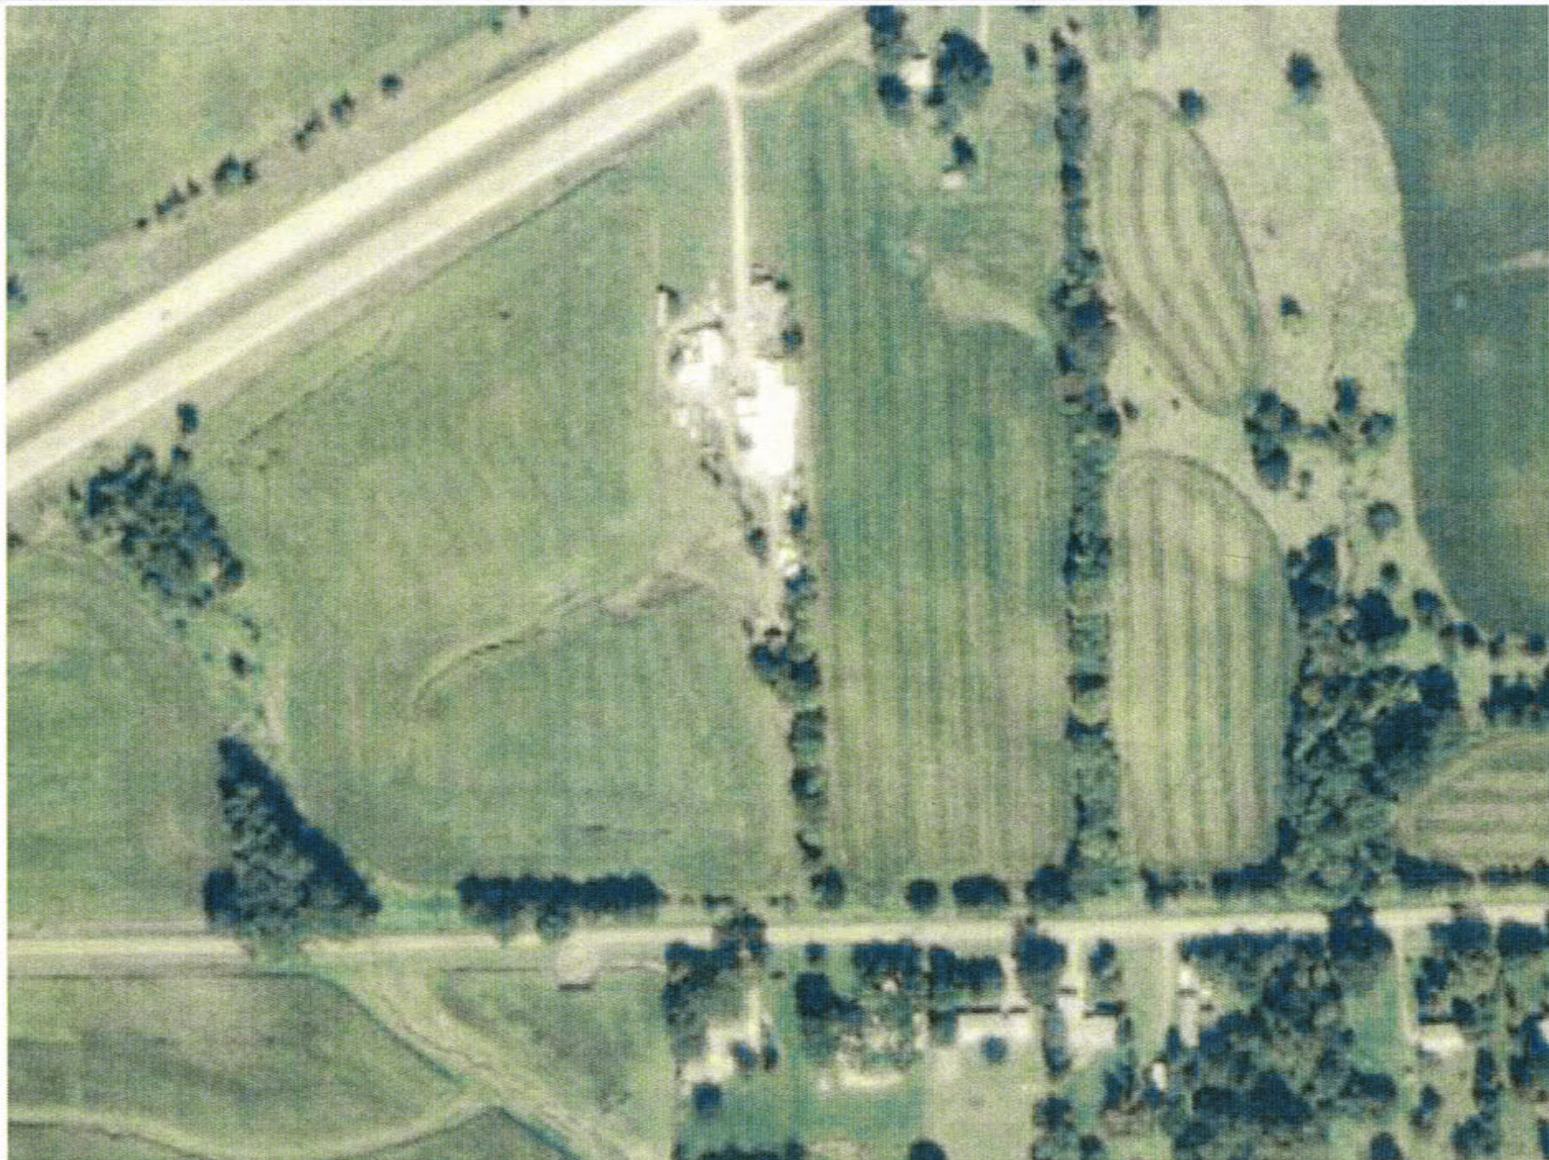
Map 6: 2009 Aerial Photograph
C.W. Process Company, Cedar Rapids, Iowa

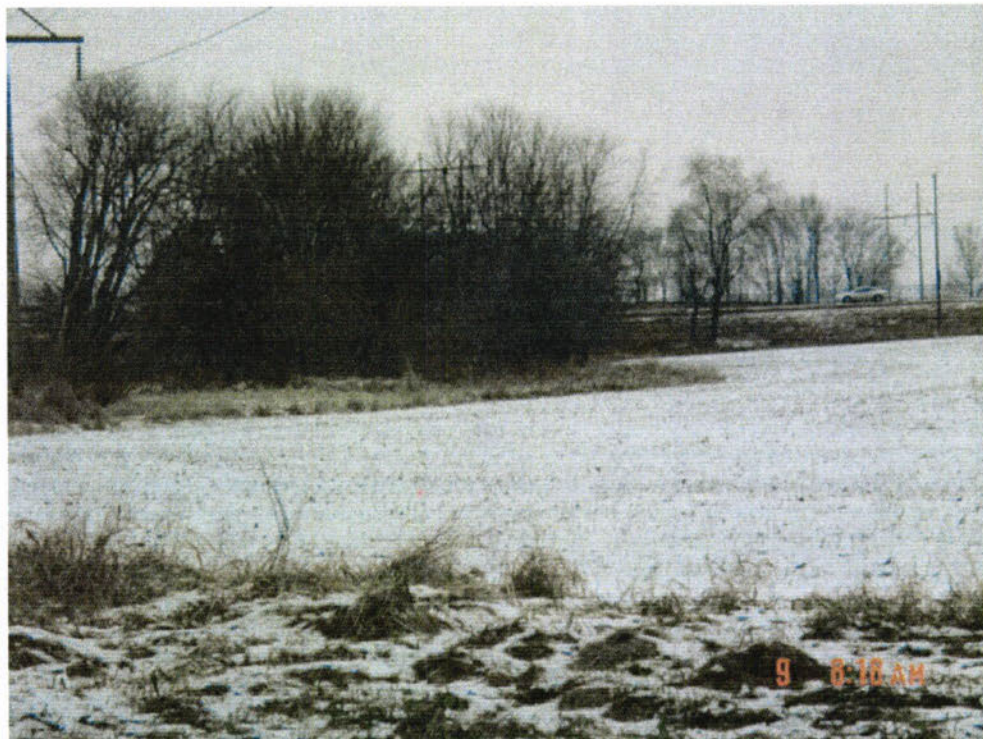
Photo 7; December 9, 2010, 0818; Photographer: John Dixon; Facing NW.
View of the southwest corner of the west field. Location 008 is flagged.

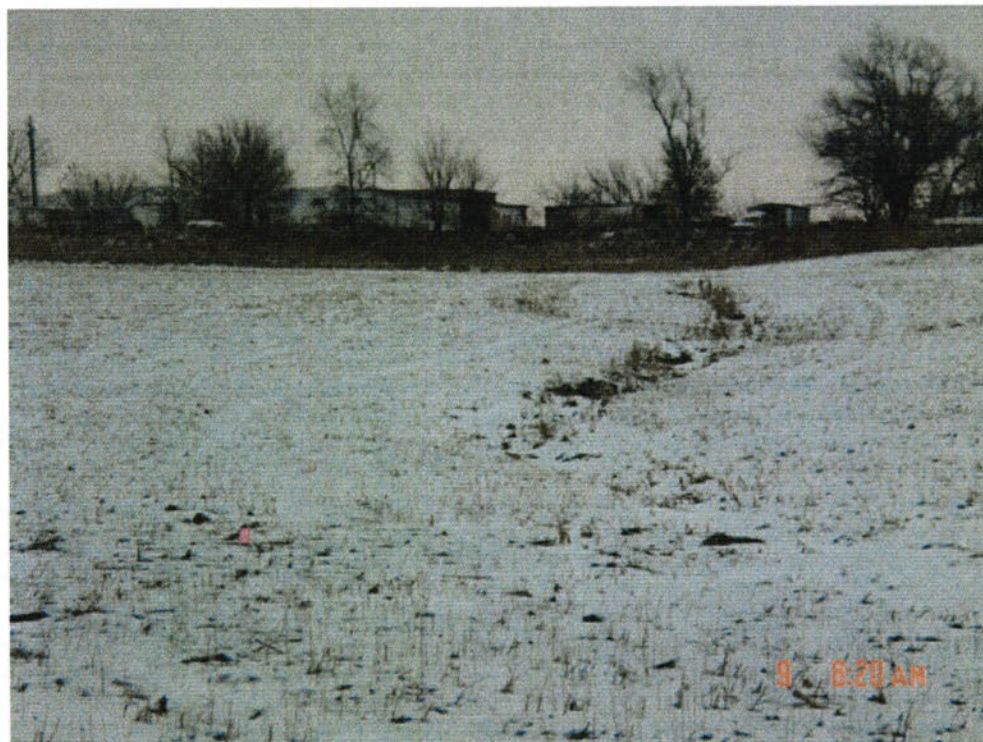
Photo 8; December 9, 2010, 0820; Photographer: John Dixon; Facing NE.
View up the drainageway bisecting the west field, looking towards the former
CW Process site. Locations 007 (near) and 006 (far) flagged.

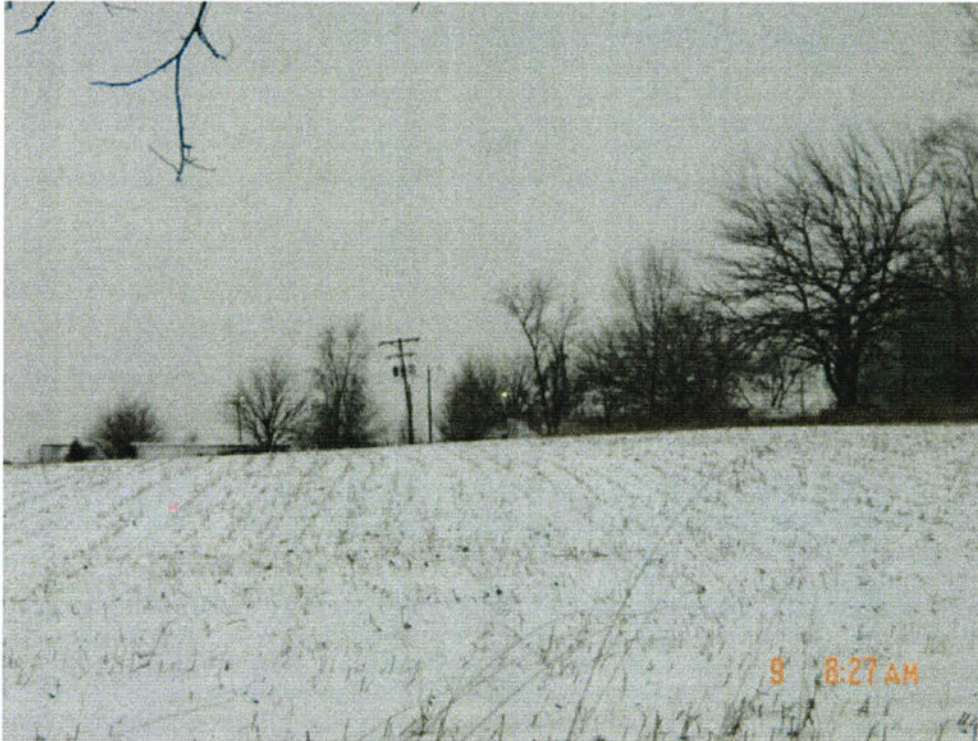
Photo 9; December 9, 2010, 0827; Photographer: John Dixon; Facing NNE.
View of the east side of the west field, looking toward the former CW Process site. Location 010 is flagged.

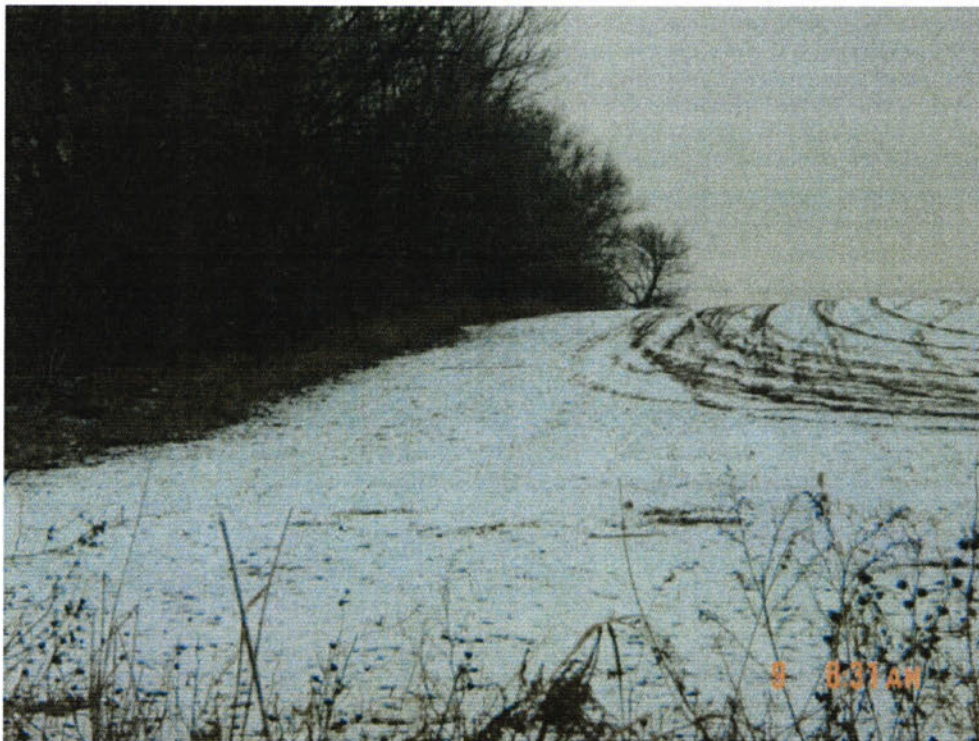
Photo 10; December 9, 2010, 0831; Photographer: John Dixon; Facing N.
View up west side of the east field, from the 33rd Avenue right-of-way (former CW Process site is to the left). Location 011 is flagged.

Each of the maximum RCRA metals detections presented in Table 11b were from Location 011. As described in Table 4, the groundwater at Location 011 was extremely turbid with silt at the time of sampling. This excess silt is likely the cause of the elevated number and concentrations of the RCRA metals shown in Table 11b. Only three RCRA metals were detected from the groundwater sample at Location 013, which was significantly less turbid (barium at 126 µg/L, manganese at 56 µg/L, and nickel at 4.6 µg/L). Therefore, the screening results shown in Table 11b are not thought to represent actual risks from groundwater southeast of the source area.

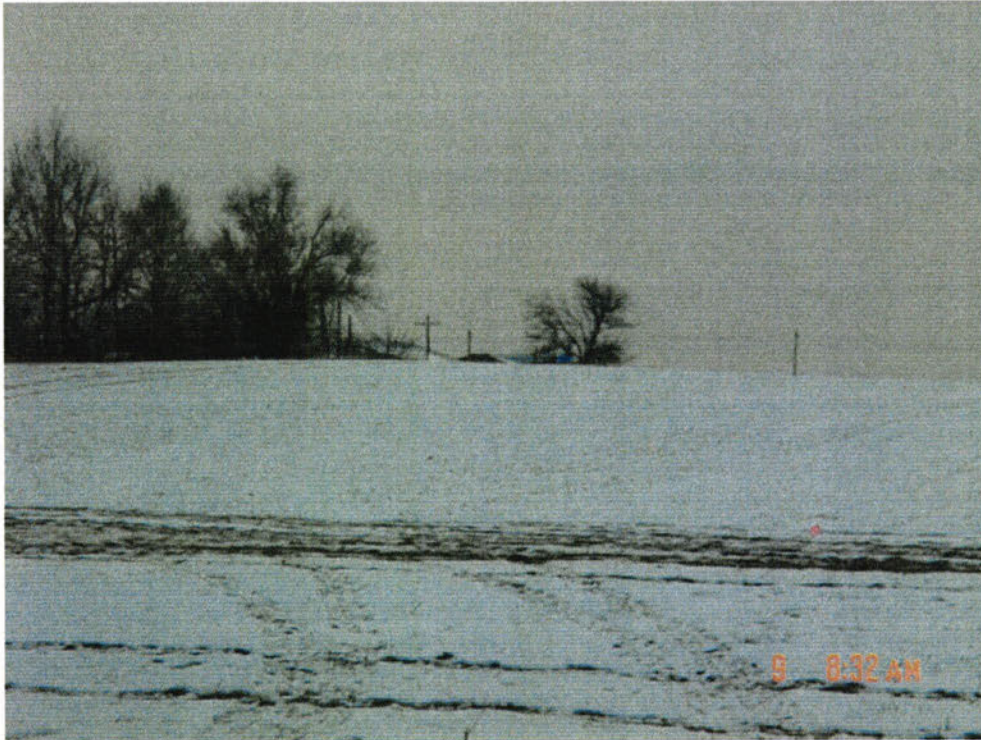
Photo 11; December 9, 2010, 0832; Photographer: John Dixon; Facing N.
View of east field (former CW Process site to the left). Location 013 is flagged.

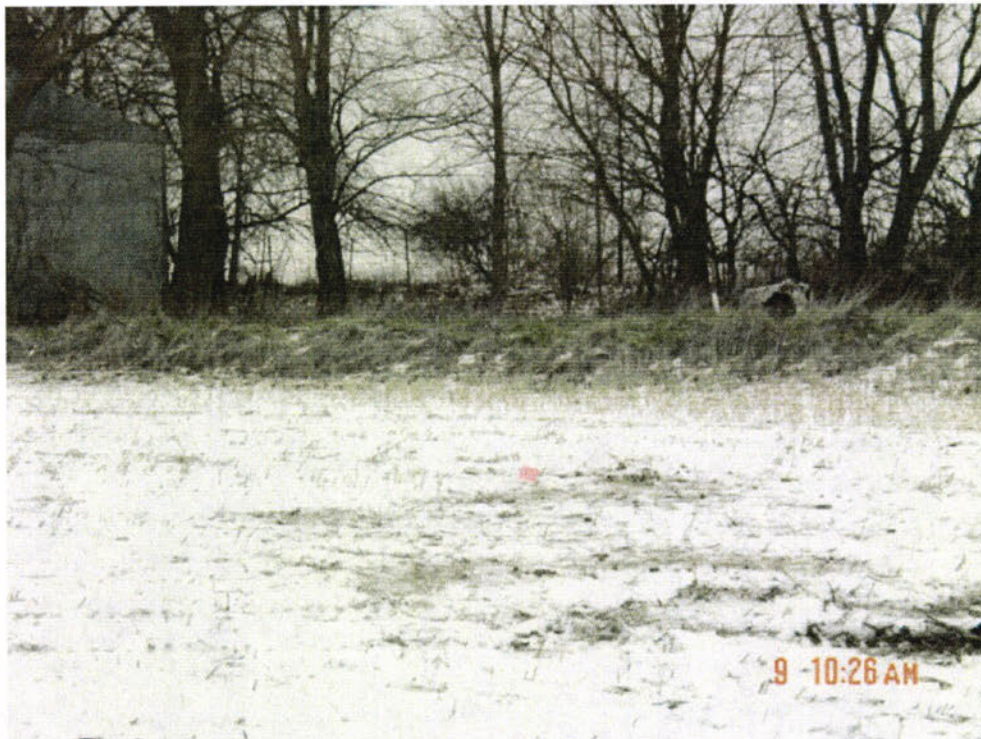
Photo 12; December 9, 2010, 1026; Photographer: John Dixon; Facing NE.
View of Location 009 (flagged), facing the former CW Process site. An apparent, former groundwater monitoring well is visible in the treeline.

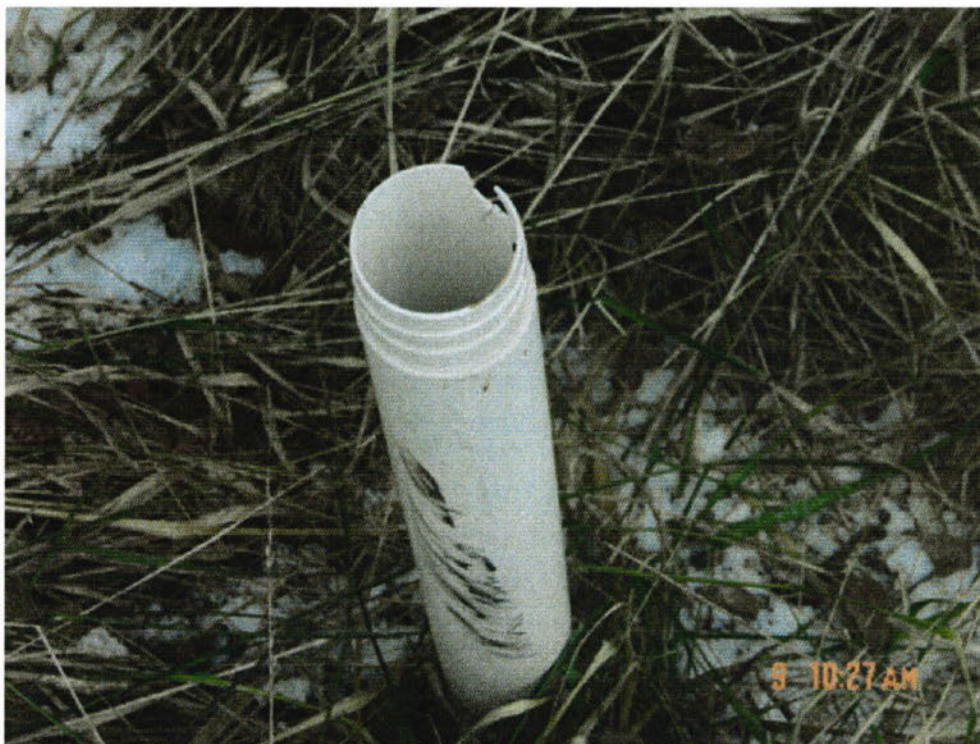
Photo 13; December 9, 2010, 1027; Photographer: John Dixon; Facing down. View of the apparent, former groundwater well shown in Photo 12. Two-inch, open-topped PVC pipe. The well was gauged and was dry.

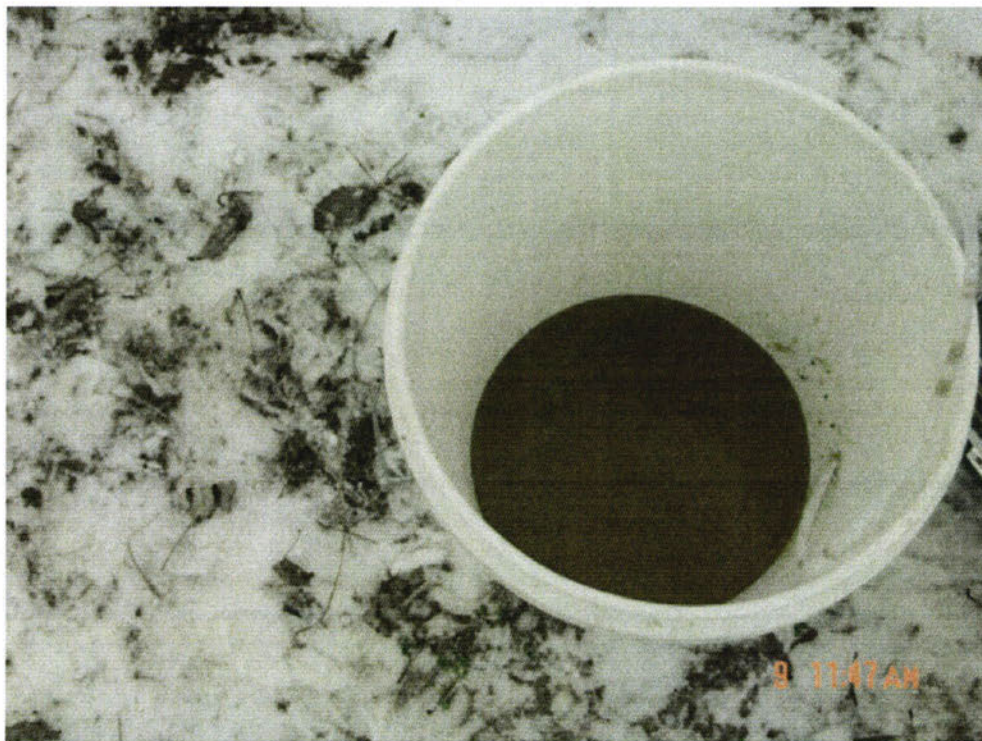
Photo 14; December 9, 2010, 1147; Photographer: John Dixon; Facing down. View of the groundwater purged from Location 008. Minimal water and heavily sediment-laden.

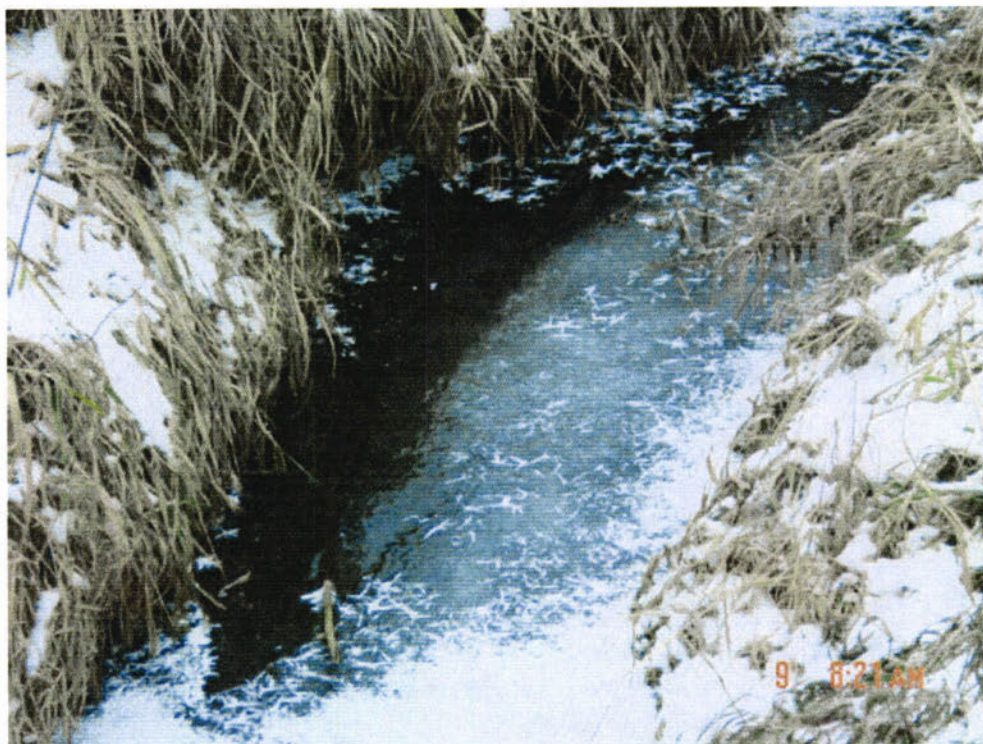
Photo 15; December 9, 2010, 0821; Photographer: John Dixon; Facing N.
View of the surface water near Location 004 (southwest corner of the west field).
Water is frozen.

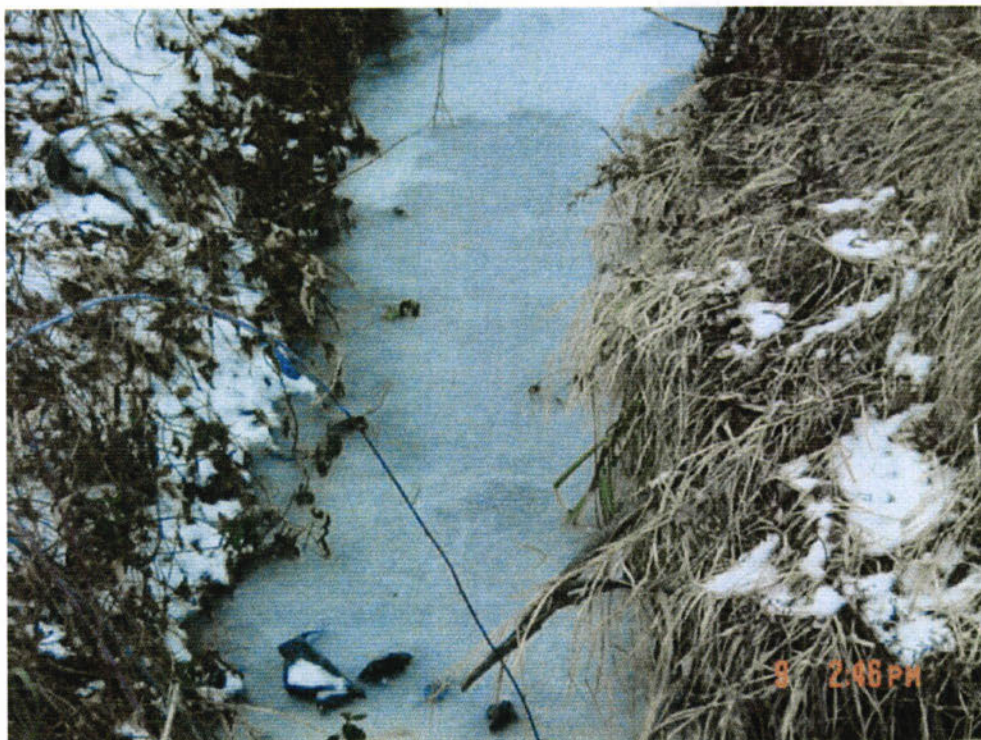
Photo 16; December 9, 2010, 1446; Photographer: John Dixon; Facing N.
View of the surface water near Location 004. Water is frozen.

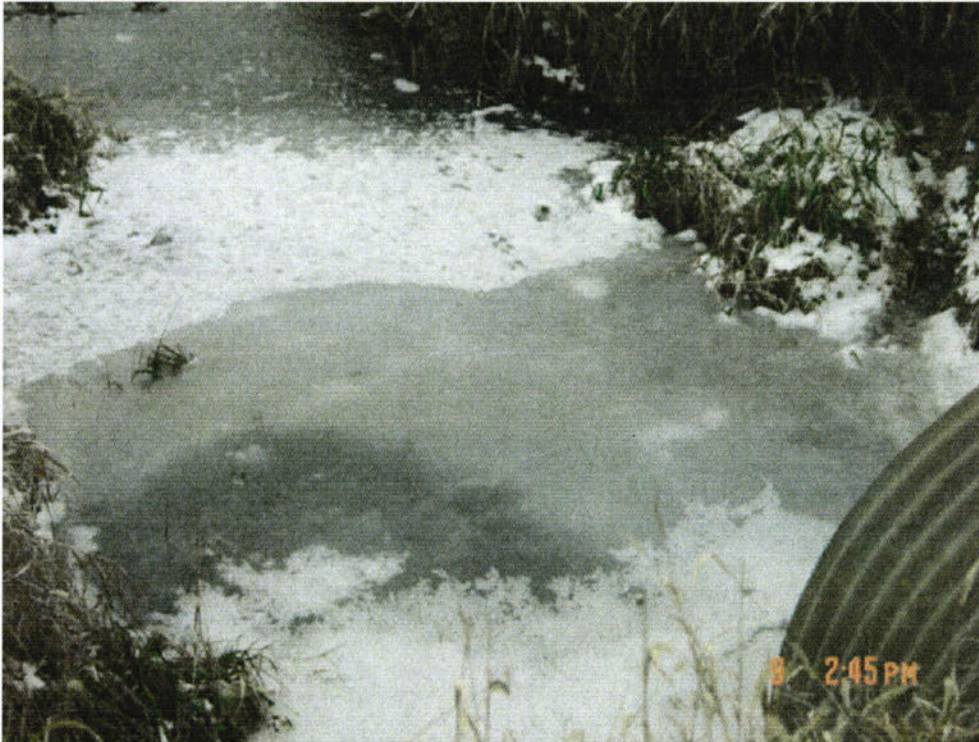
Photo 17; December 9, 2010, 1445; Photographer: John Dixon; Facing SW.
View of the surface water leaving the site (downstream) from culvert under 33rd Avenue. Water is frozen.

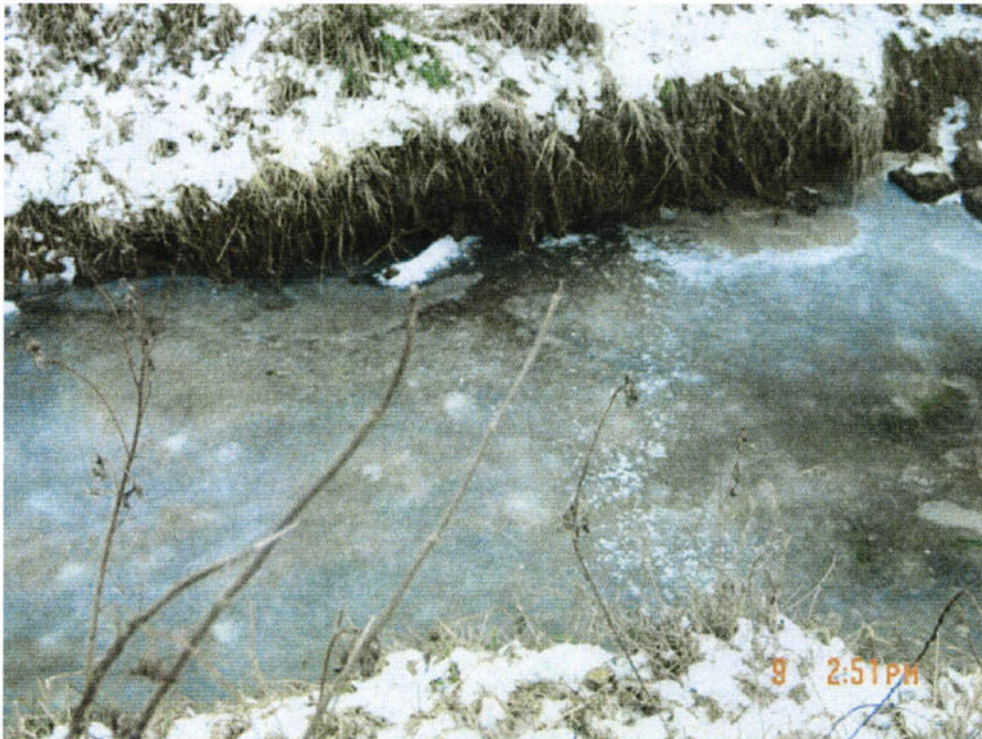
Photo 18; December 9, 2010, 1451; Photographer: John Dixon; Facing W.
View up surface water near Location 003 (upstream, coming onto the property).
Water is frozen.

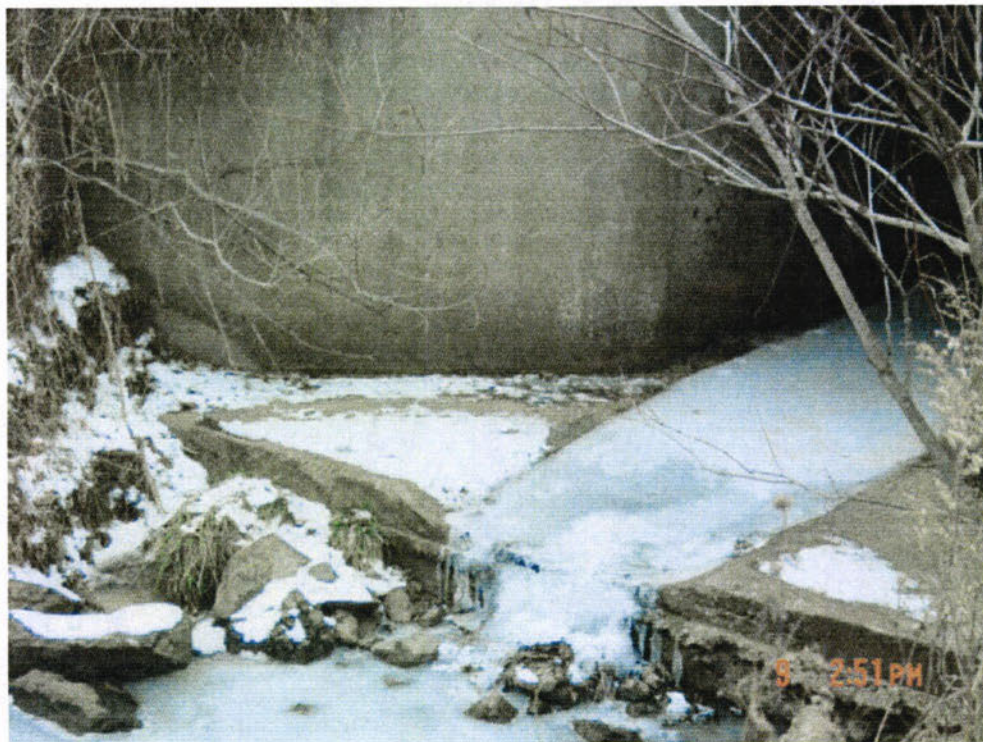
Photo 19; December 9, 2010, 1451; Photographer: John Dixon; Facing NW.
View of the surface water coming onto the property west of the west field (from under Williams Boulevard). Water is frozen.

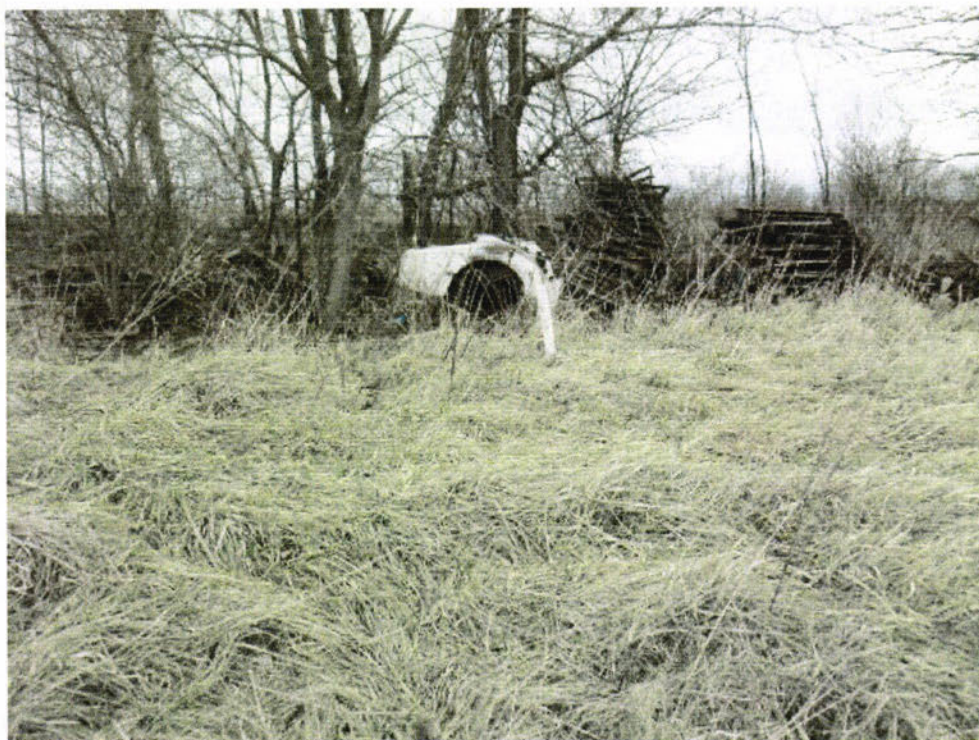
Photo 20; April 4, 2011, 1058; Photographer: John Dixon; Facing E.
View of the existing well south of the former CW site (TMW1).

It should be noted that cyanide was not detected in the surface water from west fork of the unnamed tributary (Location 002). Cyanide was detected at significant concentrations in the Existing Well south of the source area. However, groundwater samples between the Existing Well and Location 004 could not be obtained with the Geoprobe unit (apparently due to swelling subsurface clays). As such, the source of the cyanide in the surface water samples at Location 004 could not be definitively determined.

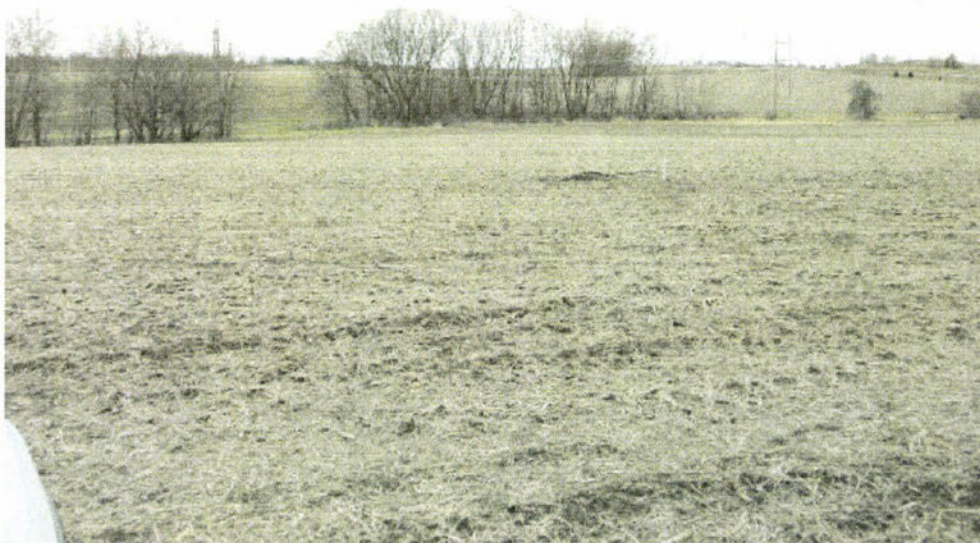
Photo 21; April 4, 2011, 1058; Photographer: John Dixon; Facing W.
View of Location 009 (PVC riser) from the existing well TMW1.

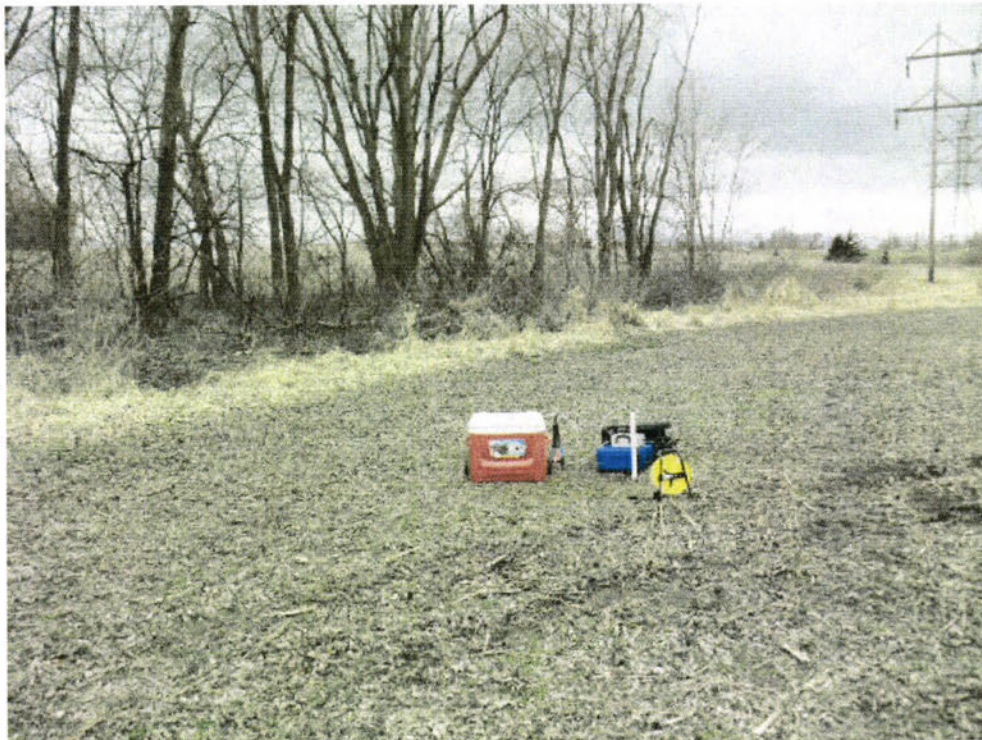
Photo 24; April 4, 2011, 1233; Photographer: John Dixon; Facing NW.
View of groundwater purging at Location 008. Unnamed tributary west of the former CW Process site is beyond the trees on the left of the photograph.

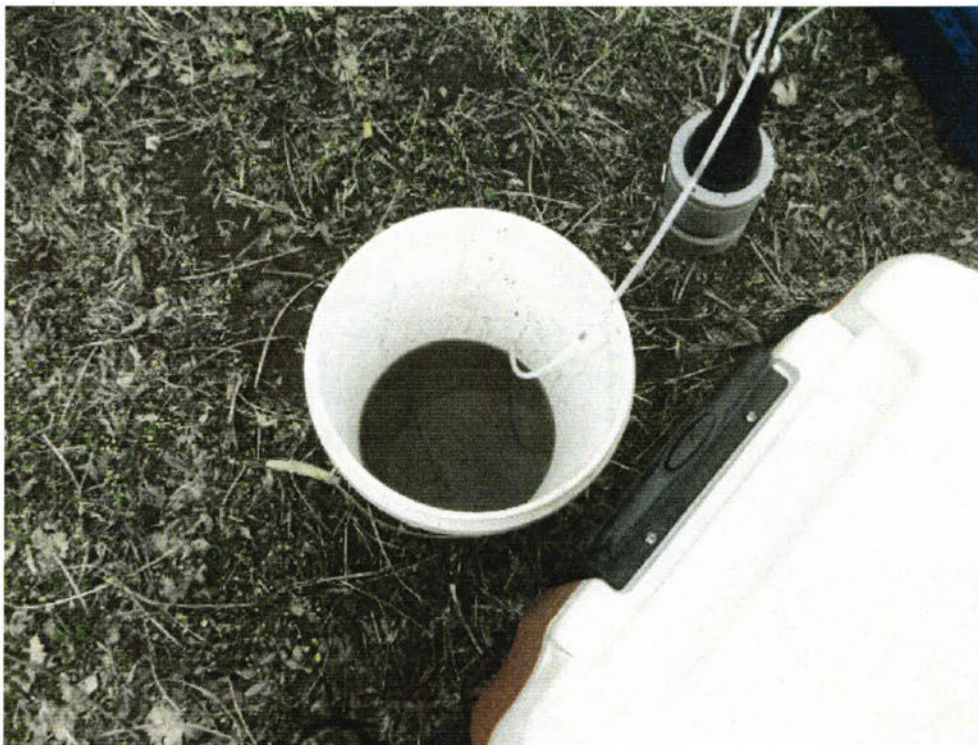
Photo 25; April 4, 2011, 1234; Photographer: John Dixon.
View of the groundwater purged from Location 008. Heavy silt content and slow production rate (less than 100 mL per hour).

Groundwater samples could not be collected at the majority of the planned locations primarily due to lack of water production in the Geoprobe-driven screens (assumed to be caused by swelling subsurface clays). None of the planned samples west of the CW Process source area (between the source area and the unnamed tributary) could be collected. The only groundwater samples collected during this Site Sampling Visit were from an Existing Well (south of the source area), and from Locations 011 and 013 (southeast of the source area).

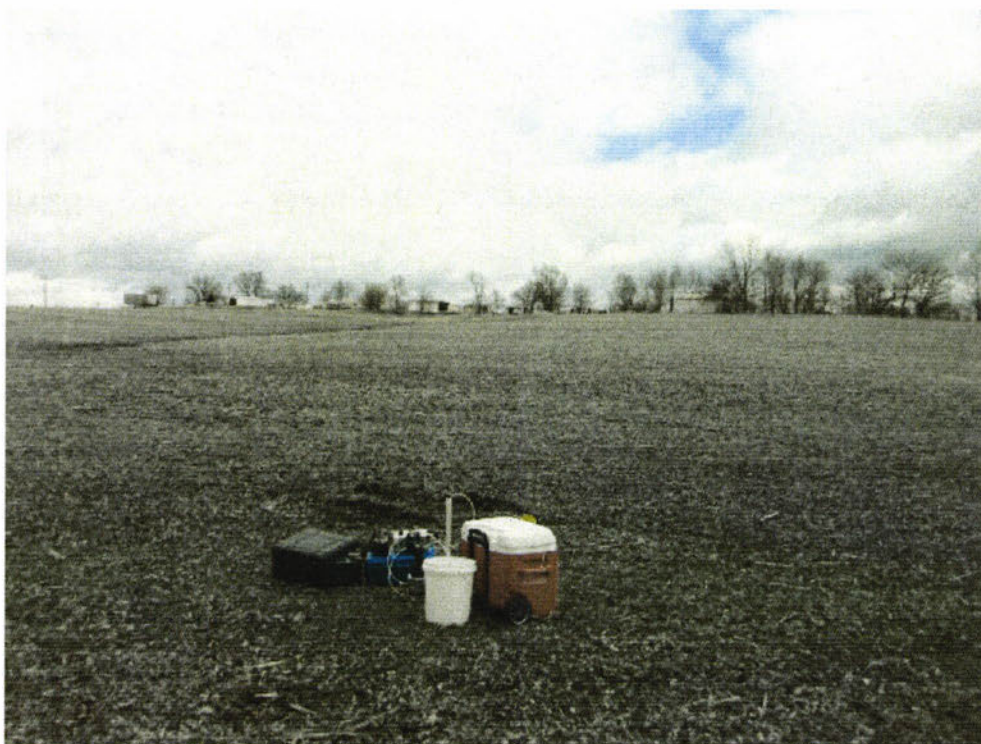
Photo 26; April 4, 2011, 1234; Photographer: John Dixon; Facing NE.
View of Location 008 (near), looking towards the former CW Process site.

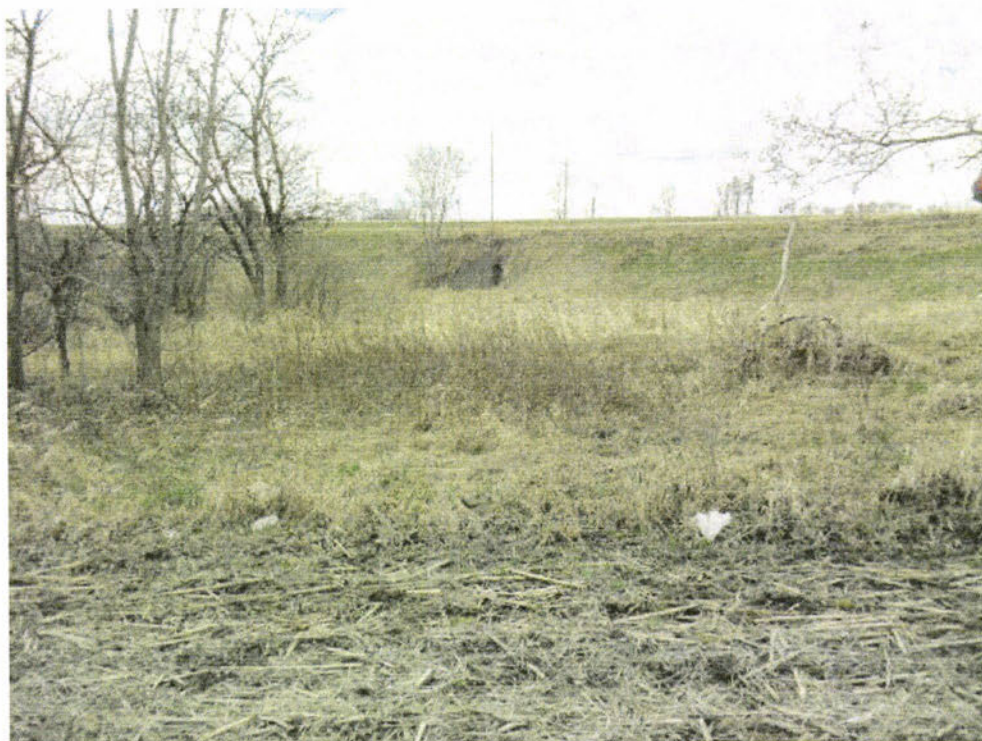
Photo 27; April 4, 2011, 1538; Photographer: John Dixon; Facing NW.
View of the surface water coming onto the property west of the west field (from under Williams Boulevard). Sampling Location 003 below culvert.

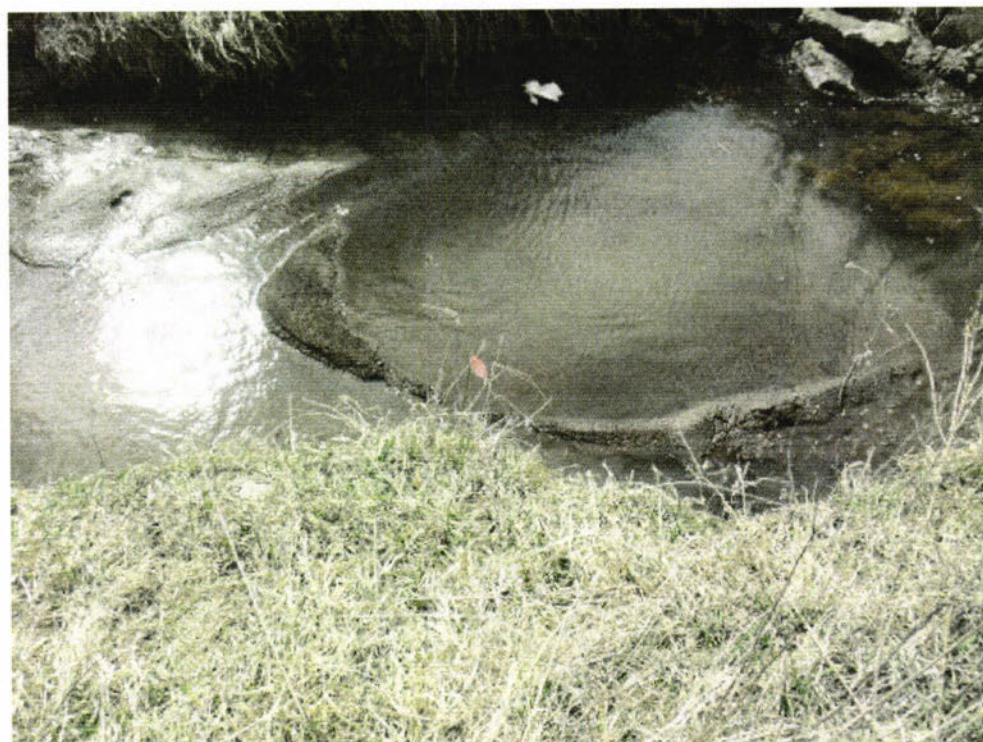
Photo 28; April 4, 2011, 1526; Photographer: John Dixon;
Close-up view of Sampling Location 003.

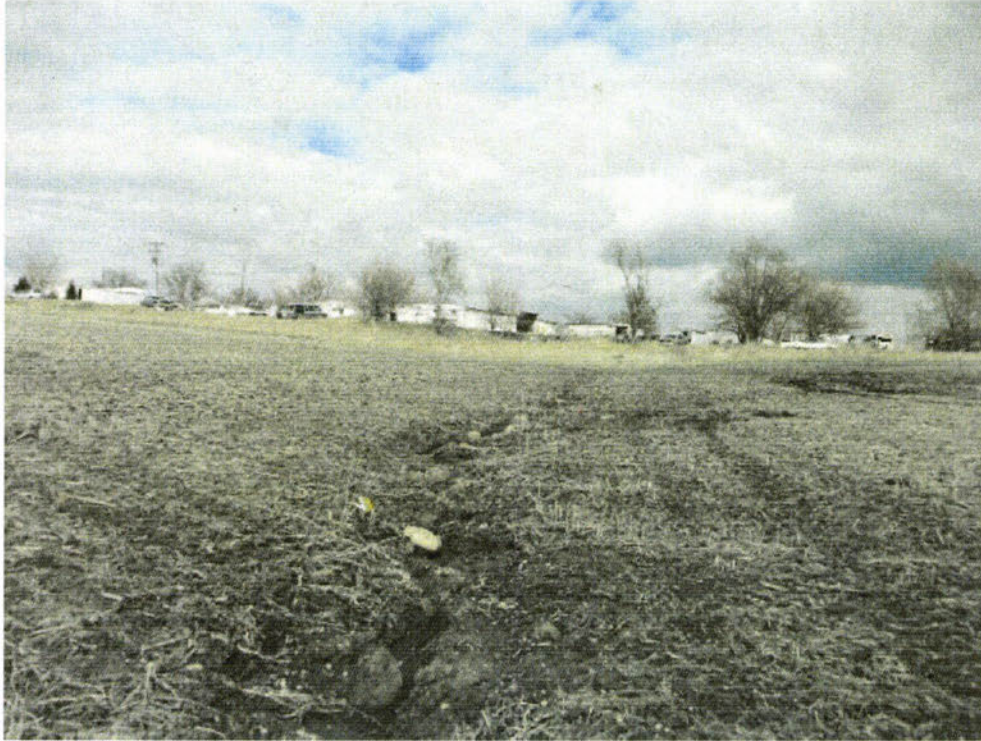
Photo 29; April 4, 2011, 1547; Photographer: John Dixon; Facing ENE.
View of sediment Sampling Location 001 (near yellow logbook and adjacent rock) within the drainageway running SW from the former CW Process site.

- The SAP lists surface water and sediment sampling at Locations 001. This location was sited in a drainageway running southwest from the former CW site. During the sampling event, it was noted that no surface water was present in this drainageway. Location 001 was moved southwest of its SAP location (to a low area with ample sediment), and only the sediment sample was collected.

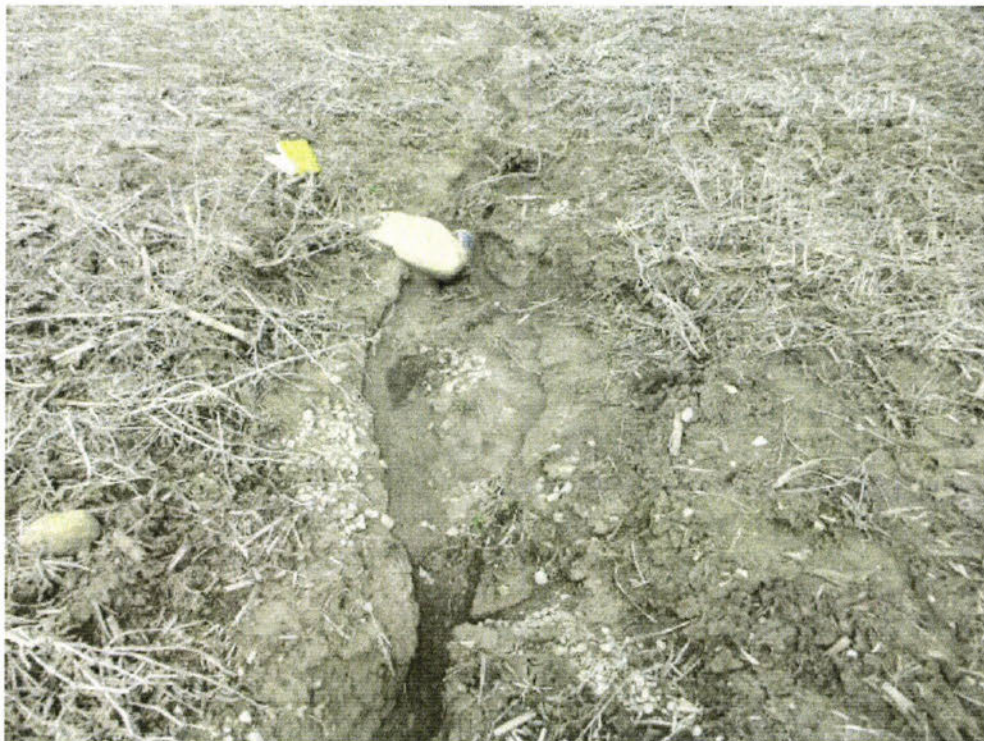
Photo 30; April 4, 2011, 1547; Photographer: John Dixon; Facing ENE.
Close-up view of sediment Sampling Location 001.

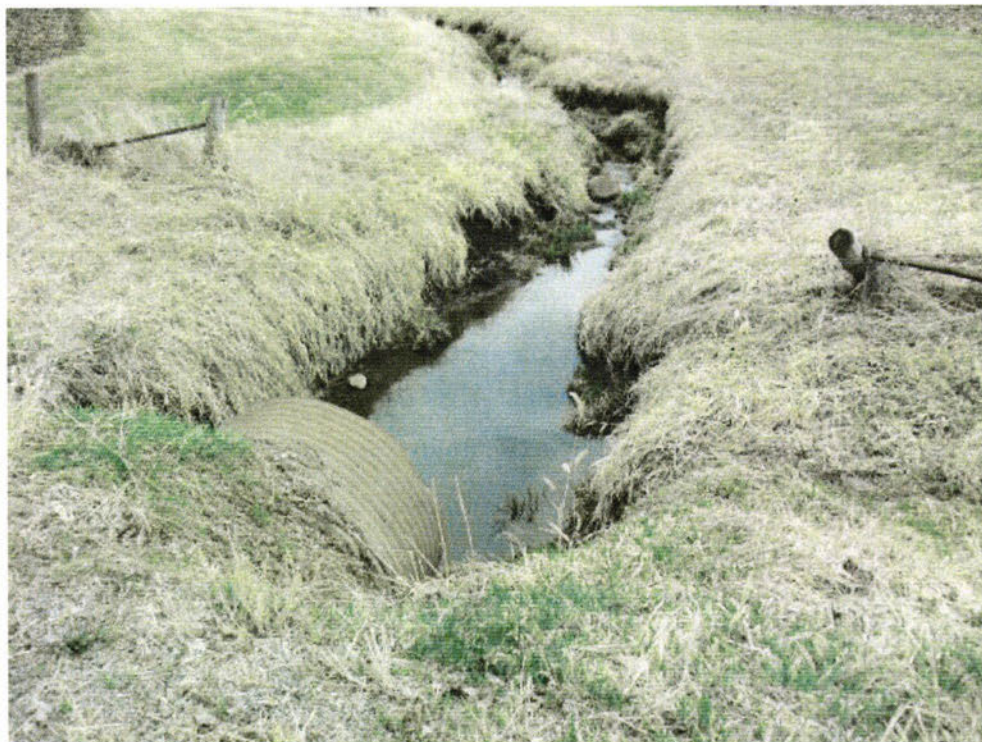
Photo 31; April 4, 2011, 1550; Photographer: John Dixon; Facing SSW.
View of Sampling Location 005 from 33rd Avenue.
